# Analyzing and Solving Stability Problems during the Commissioning of the Steam Turbine

Klodian Gumeni

**Abstract:** The commissioning of the steam turbine in the CCPP of Vlore (Albania) was carried out after a shutdown of about one year. During previous operation of the unit, in particular in a couple of shutdowns, were observed high vibration at bearing MAD 21. Before the restart, the oil deflector of the MAD21 bearing (the bearing located in the front standard, on the inlet side of the steam turbine and adjacent to the clutch) was modified increasing the radial clearance on the part of the oil deflector acting as a thermal shield with the aim of eliminating / preventing the risk of rubbings. Rubs at the location of the above mention oil deflector were considered as the very likely cause of high vibration at bearing MAD 21. A lot of tests were carried out during the recommissioning phase and the data received were analyzed. This paper details the discovery of the problems, initial attempts to address them and the use of the rotor dynamics tools to find a solution of the problem by the optimization of the bearings. The bearings were not optimized as per rotordynamics analysis (

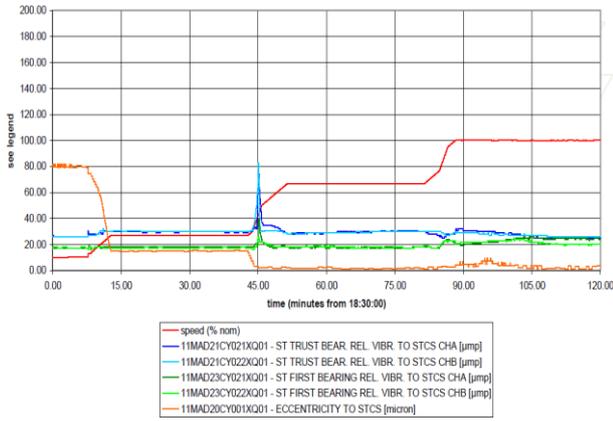
Figure 1. Cold start trends

- a) acceptable vibration behaviour during startups: the maximum vibration is recorded at bearing MAD21 at the 1st critical speed of the steam turbine and it is about 80-85  $\mu\text{m}$ , 0-p (relative vibration of rotating parts: alarm set at 75  $\mu\text{m}$  0-p). Significantly lower vibration levels at bearing MAD 23.
- b) no differences during the cold or hot startup [4].
- c) good vibration behaviour during shut down, with a max vibration level of about 45  $\mu\text{m}$  0-p at bearing MAD 21.
- d) good vibration behaviour at load: about 31  $\mu\text{m}$  0-p at brg. MAD21, about 20  $\mu\text{m}$  0-p at brg. MAD23. Both values refer to rotating parts.
- e) low vibration levels, both during speed transients and at load, for both bearings on stationary parts.

Usually the vibration behaviour is rougher during runs down than runs up, because speed gradients through critical speeds cannot be controlled during shutdown and therefore the speed gradient is lower, allowing vibrations to develop at critical speeds. A bearing reaching and passing alarm level during speed transient can be accepted if vibration levels at load are good. No accepted common vibration standard requires vibration below alarm level during speed transients.

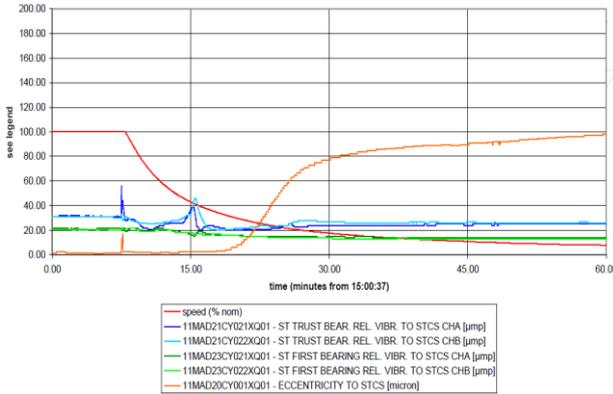
Figure 2. Shut down from base load

As a matter of fact the vibration behaviour of the steam turbine after the correction activity was reasonably good. In particular during the rundowns, no vibration increase was observed at all or related to rubs as previously occurred.

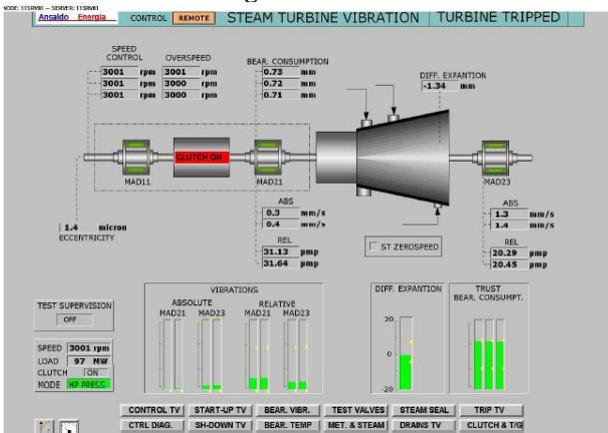
Figure 4. Print screen of operation at load (clutch engaged)

At load the vibration behaviour of the steam turbine can be classified as just within class A of ISO 7919-2 (A/B boundary 80  $\mu\text{m}$  pp per ISO 7919-2) [5].

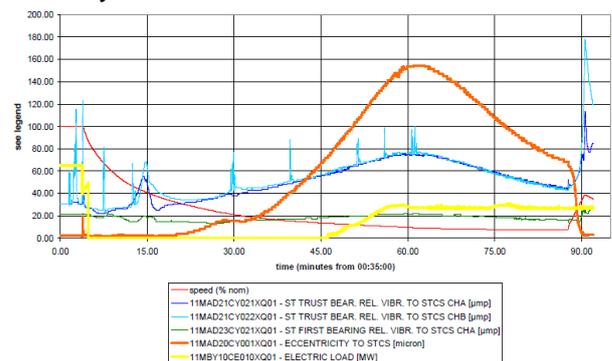
Figure 5. Trip and 1<sup>st</sup> restart

A steam turbine trip occurred due to high vibration of brg. MAD21 (MAD21CY22 sensor).

It was quite immediately clear that the high vibration was due to a spike occurred at sensor MAD21CY11 (relative vibration, rotating part) of brg MAD21. Analyses carried out on the data provided by site confirmed the initial findings:

- No vibration occurred at sensor A of brg. MAD21, neither to brg MAD23
- No vibration increases occurred on stationary parts

Other spikes were recorded before and after the trip at the same sensor. Checks carried out later on the signals and sensors indicated a probe converter faulty for the relative vibration measurement of brg. MAD21 sensor A.

A restart of the steam turbine, after about 1 ½ hour from the trip, was carried out but a trip occurred at about 1100 rpm, for high vibration at brg. MAD21.

Analysis of the data provided shows a quite uncommon behavior of bearing MAD21 vibration (at both sensors A and B) during run down, i.e a significant vibration level increase during run down with a maximum of 75 µm about one hour after the trip with the steam turbine at about 300 rpm. This is a very high and uncommon vibration level for such a low rotating speed [7]. Later the vibration behaviour trends tend to decrease, but at the moment of the 1st (aborted) restart still higher than the value that ( looking at the data of other run down and start up) can be considered typical for the unit [3].

Also the eccentricity reading, compared with readings of other run downs and run ups, indicates an uncommon behaviour ( increase up to 155 µm about one hour after the trip, against usual values of 80-100 µm) [4].

It is quite clear that the high vibration levels at the restarts are related to a temporary bowed rotor.

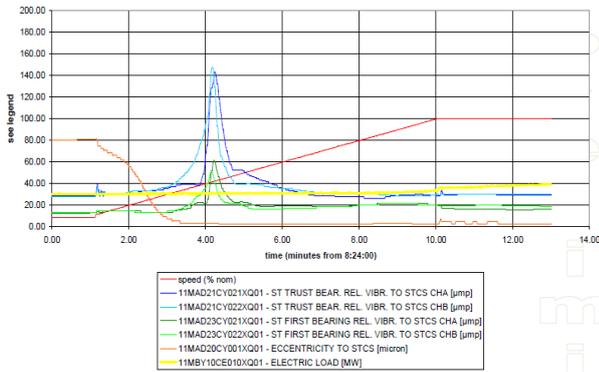
Figure 6. 3<sup>rd</sup> (hot) restart after two trips

Finally the unit was restarted about eight hours after the trip and full speed was reached, in spite of quite high vibration at brg. MAD21 (above 140 µm 0-p with a readjusted trip limit of 125 µm 0-p plus a delay of the trip of 1,5 seconds) [6].

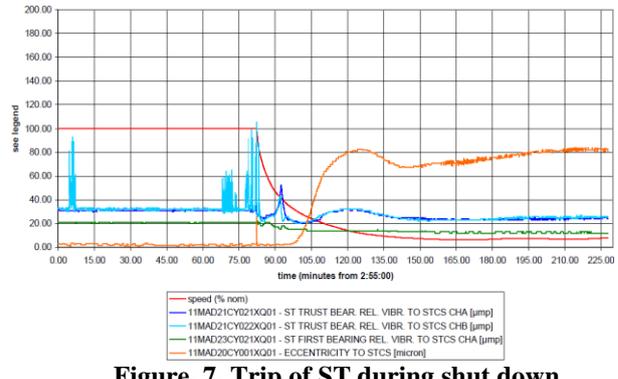
Figure 7. Trip of ST during shut down

A further trip due to brg. MAD21 relative vibration (probe CY22) spikes occurred during run down of the ST. Vibrations during run down were quite low, some increase of vibration level at brg. MAD21 as well as of the eccentricity occurred again but with levels significantly lower than the previous observed.

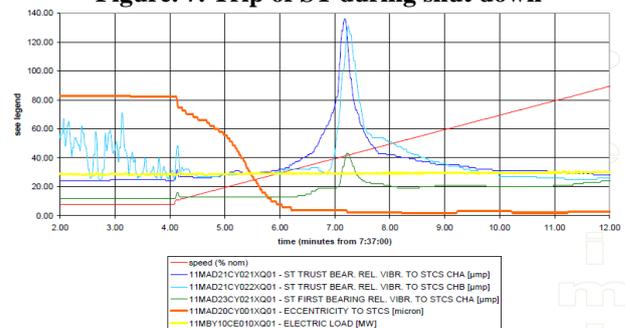
Figure 8. Hot restart of ST

The steam turbine was restarted about 3 ½ hours after the trip and full speed was reached with relatively high vibrations at brg. MAD21 at the critical speed (about 135 µm 0-p)

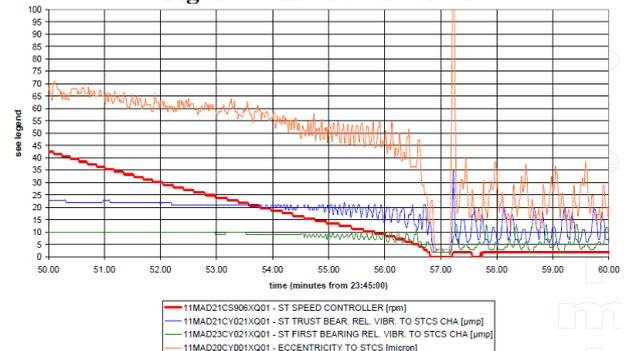
Figure 9. Trip of ST (eccentricity on turning gear)

Then a further trip occurred on the power Station (not related to steam turbine). Vibration behaviour was good during run down, 65 µm 0-p at brg. MAD21 passing through critical speed. No increase of vibration at low speed were observed and the eccentricity was “normal”.

The data of this trip, provide also a better understanding of the eccentricity reading, with the unit on turning gear. The p-p eccentricity (i.e. the so called TIR) is slightly less than 30 µm. Operation of the steam turbine during a few events was monitored too. In particular a startup, a shutdown and a trip were analyzed.

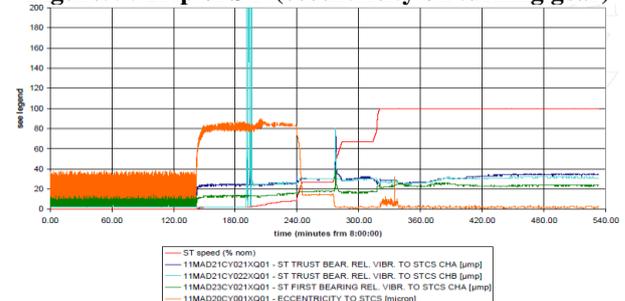
Figure 10. Startup of ST, cold condition

During the startup (a cold one), vibrations level were relatively low also at critical speed (< of 80 µm 0-p). Vibration levels at load were to acceptable values and the operation of the ST was stable.

It is also worth of note that the eccentricity before startup (with the steam turbine on turning gear) was about 30 µm pp and reached a reading of 80 – 90 µm with the steam turbine revolving at a couple of hundreds of rpm.

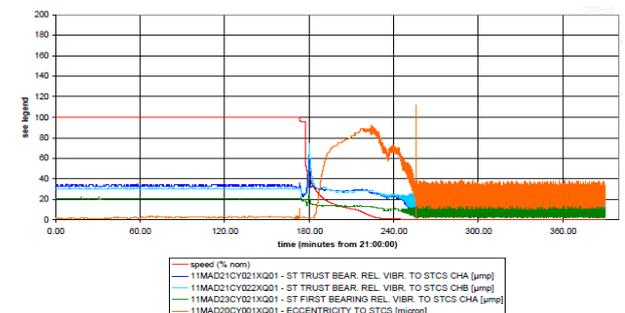
Figure 11. Emergency shutdown

During the shutdown, vibrations at critical speed were quite similar to them on start up. No significant increase of vibration at low speed, eccentricity behaviour “regular” with usual 30 µm on turning gear.

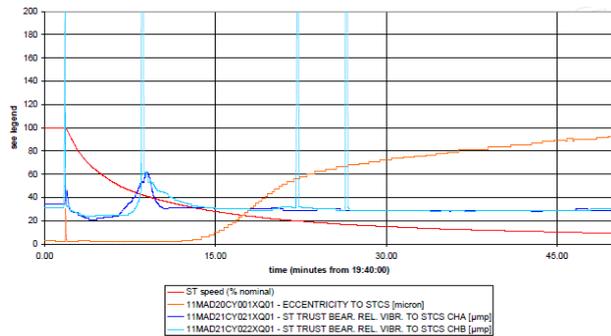
**Figure 12. Trip of ST, high relative vibration**

A steam turbine trip occurred due to spikes of the MAD21 sensor CY22 (relative vibration). Vibration at MAD21 brg at critical speed were normal as well as at low speed. Eccentricity at low speed (no turning gear data available) still “normal”.

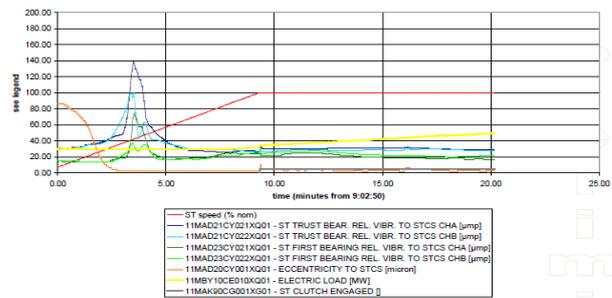
**Figure 13. Startup of ST, cold condition**

Vibration up to 140  $\mu\text{m}$  0-p at MAD21 brg. were observed during the startup in cold condition. This vibration level is about twice the vibration observed during the previous cold startup, but at the same level of other hot starts.

At load, the vibrations are at the usual levels (30  $\mu\text{m}$  0-p for brg.MAD21, 20  $\mu\text{m}$  0-p for brg. MAD23)

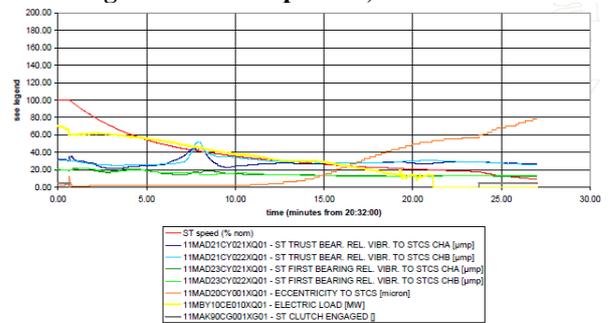
**Figure 14. Shutdown of ST**

The shutdown of ST was with low vibrations at brg. MAD21 (just above 50  $\mu\text{m}$  0-p), there were no significant vibration at low speed, eccentricity initially regular with some increase after turning gear engagement at low speed (max value from the data available 100  $\mu\text{m}$ ).

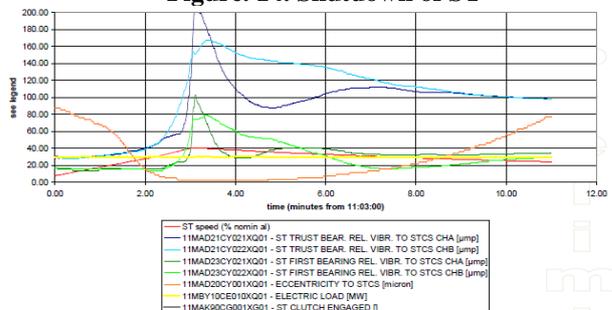
**Figure 15. Failed startup, warm condition**

At the restart of ST in warm condition, 15 hours after the trip, the vibration increased soon to high levels causing the trip of the unit. The vibration levels just before the trip were within normal values as well as the eccentricity.

- 11) In order to avoid the ST trip during the hot starts, due to high vibration three corrective actions were recommended. To increase the threshold and time delay of trip for relative vibrations and to increase the gradient of the speed near the critical velocity.
