# Piston Failure Analysis on Four-Wheeled 1000cc Engine Cylinder Capacity

**Abstract:** *Pistons are one of the main components of a 1000 cc engine that functions as a pressure suppressor and a recipient of pressure combustion in the combustion chamber. In the examination of the 1000 cc sedan engine that has been operating for 30,000 hours found a rough sound on the engine and experienced loss compression on the cylinder block number 2. The purpose of the study was to obtain the factors causing the deformation of the piston 1000 cc sedan vehicles. The research method used is metallographic observation using ASTM E 3 and ASTM E 112, testing hardness using ASTM E 92 and SNI 19-0409-1989 and testing chemical composition using ASTM A 751. The results of research on piston damage can be seen that observation macrostructure proves that there is plastic deformation on the surface area of the piston material, the results of microstructure observation are known to occur microcrack on the top surface of the right side of the piston, there is no change in microhardness between the piston material in the deformed area with the deformed piston material hardness, piston material made of alloy A

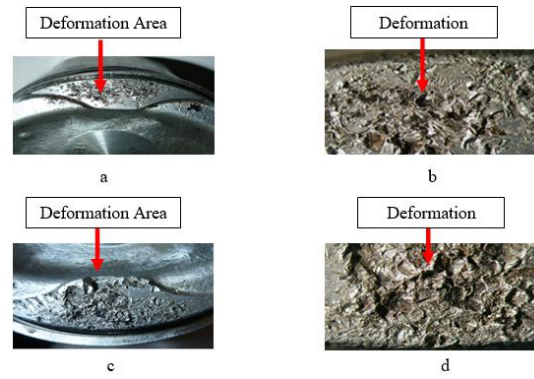
**Fig. 3. Macrostructure of the piston upper surface is deformed**

Fig. 3 shows the deformation on the surface of the left and right sides of the piston. Deformation on the top surface of the piston is thought to be due to a collision with the cylinder head caused by a buildup of scale on the piston top.

- a. Areas of the left side of the piston surface that are deformed.
- b. Areas of the left side of the piston surface that are deformed. (Zoom: 25x)
- c. The area of the right side of the piston surface deformed.
- d. The area of the right side of the piston surface deformed. (Zoom: 25x)

Damage that occurs at the top (side of the combustion chamber) in the form of defects due to the impact of the piston with the cylinder head that causes deformation of the piston material [5]. Also, on the surface of the piston visible black crust that is thick enough to stick to the piston surface. The damage can cause defects in the piston which is thought to result in rough engine noise and loss compression.

The impact of the instability of the compression step is the occurrence of loss compression which will result in incomplete combustion resulting in a pile of soot crust leftover from the combustion chamber and stacked on the piston surface [10], [11]. Thus the handling carried out to repair the problem is to replace a new piston.

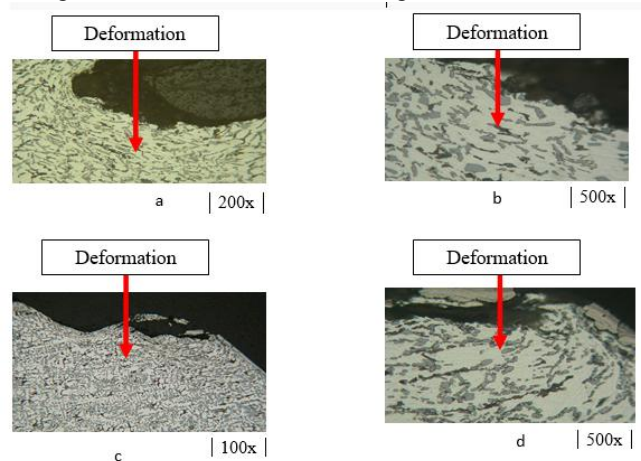
**Fig. 4. Surface microstructure of a 1000 cc piston sedan**

Caption of Fig. 4 are (a) a and b microstructure test results of the left side of the upper surface of the piston material (b) c and d of the microstructure test results of the right side of the upper surface of the piston material Figure 4.

Shows the elongated piston sample cut that has a defect due to a large impact load. This is supported by structural deformation. In the deformation area of the right side of the piston surface, the hardest impact occurs and is expected to cause cracks in that area [6], [7]. Whereas in the deformation area of the left side of the piston surface only small deformations occur that do not cause crack. The occurrence of small cracks or microcrack in the deformation area of the right side of the piston surface can be seen in Fig. 5.

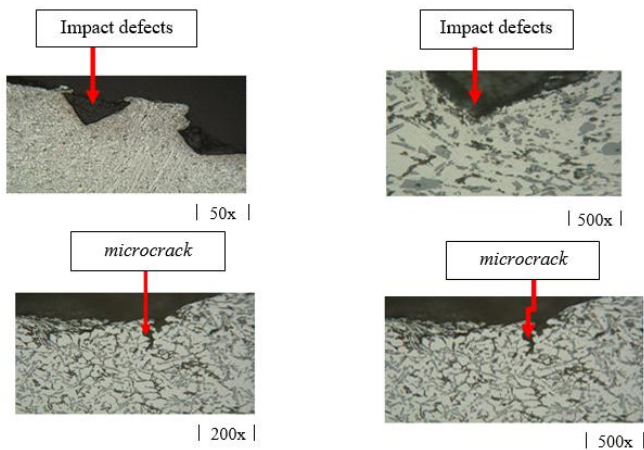
Fig. 5. Defects on the piston (etching: 50x, 100x, 200x, and 500x magnification)

Fig. 5 provides information that there is a sharp defect that forms an angle that is indicated to hit an object that is sharp enough. In the area of impact found a fine crack or microcracks.

The fine cracks form a cavity or hollow which has an impact on the performance of the piston decreases, causing an effect on the engine in the form of symptoms of loss compression and noise.

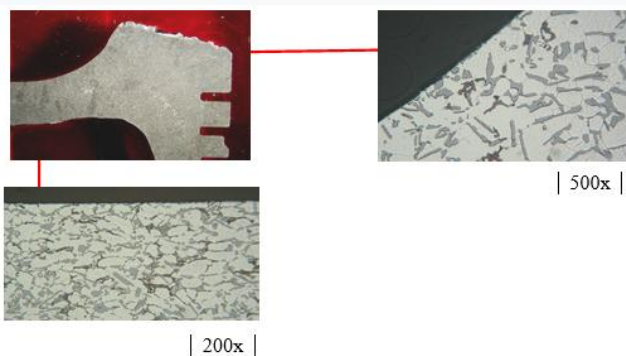
Fig. 6. The Closest Area to the Deformation Area (etching: Dix's Keller reagent)

Figure 6 provides information that the concave surface area (middle of the piston) on the upper side piston closest to the deformed piston area does not reveal any defects. This shows that there was no collision between the cylinder head and the piston in the area caused by the buildup of scale. From the explanation of the results of microstructure testing, 3 conclusions can be drawn [8], [9], namely:

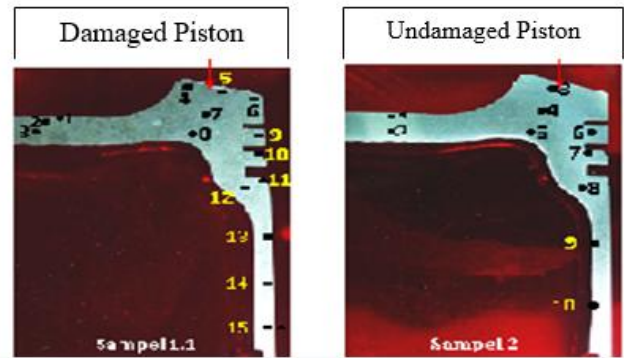
Fig. 7. Piston Material Hardness Test Point Location

Fig. 7. Shows the location of a sample of hardness tested. Sample 1 (piston that was failure there were 15 points of hardness test location and sample 2 (piston that did not suffer) there were 10 points of hardness test location.

From the violence side, it is found that there is no difference in the hardness of the material around the defect with the piston base material. This shows that deformation that occurs on the piston surface does not have an impact on the change in material hardness of the piston itself. Deformation that occurs on the top surface of the piston causes microcrack by the results of microstructure testing. The presence of a microcrack on the top surface of the piston can cause a rough noise in the engine that is sourced from the fluid pressure in the form of air in the combustion chamber decreases (failure in the adiabatic area) which causes the compression stroke to become unstable.
